**Buffer Zone Contamination Review
(Additional Assessment)**

**Prepared by the
Colorado Department of Public Health and
Environment**

April 2003

An Assessment of Site Disturbances at RFETS, April, 2003

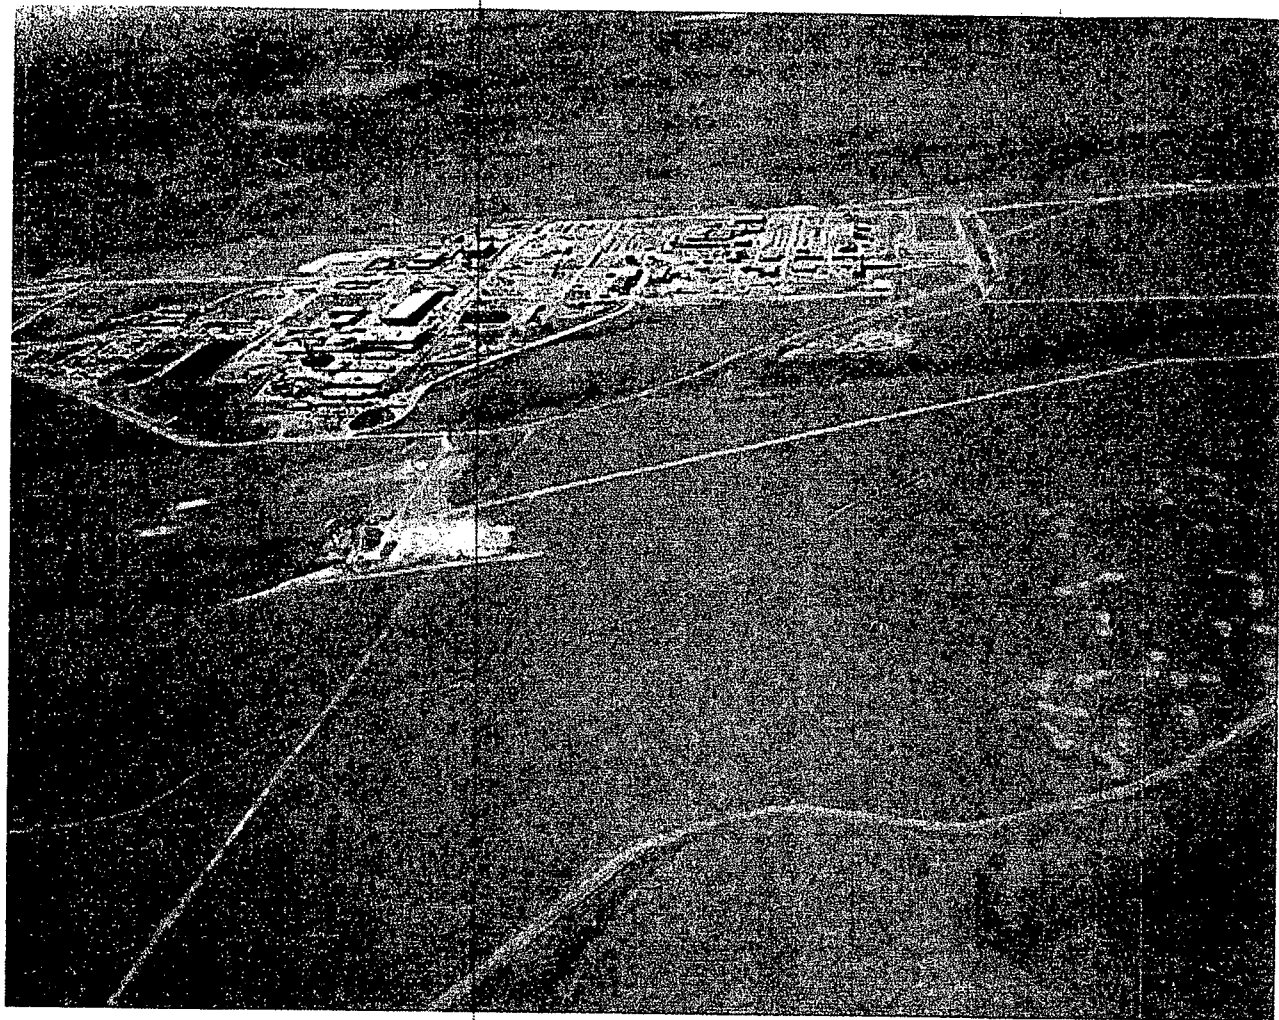
6/26/1991 Photo #42081-09: Additional Area of Interest 4.

4. The 6/26/1991 photo 42081-09 shows two dark mounds of material one north and one west of the present landfill. The material is possibly asphalt. What this material is, where it came from and what its ultimate disposition was needs to be investigated and documented.
